**NORTH WEBSTER STORM DRAIN
ENGINEERING FEASIBILITY STUDY**

KOSCIUSKO COUNTY, INDIANA

October 29, 2002

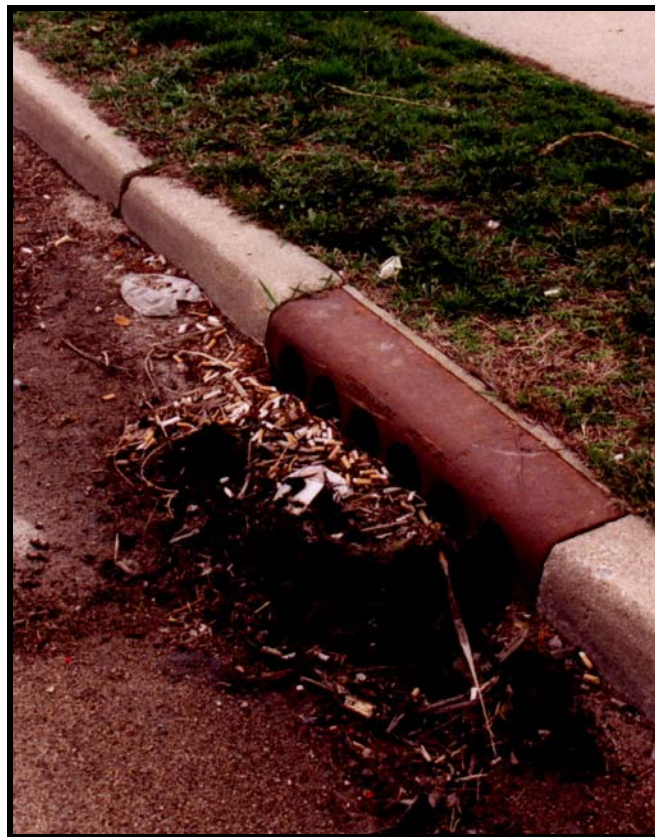
Town maps were modified and updated to include 18 drainage networks (Figure 1). Parts of the drainage infrastructure are old (Figure 5), but most of the older and newer drains are fitted with typical box drop structures also known as catch basins (Figure 6). Although it was beyond scope of the current study, some of the drain networks may require updating and resizing as development continues in the town and its watershed.

FIGURE 5. Drainage infrastructure example.

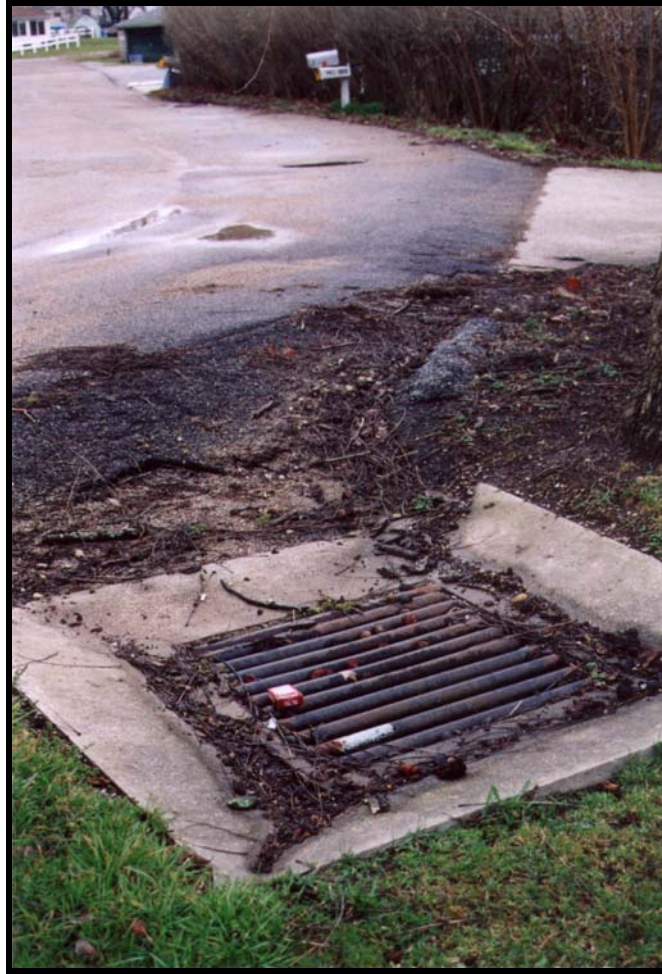
The most obvious problem observed during the feasibility study was lack of maintenance of the existing structures. As Figures 7-13 show, many of the structures were full, nearly full, or clogged with sand, gravel, lawn litter, trash, and other debris. Current research indicates that when sediment and debris fill more than 60% of the catch basin volume, the basin reaches “steady state” meaning that the basin no longer removes sediment from storm water runoff (Pitt and Bissonnette, 1984). Storm flows re-suspend sediments in the basin and pass them through the system. Based on the condition of the drains observed during the study, it is not surprising that lake residents have noted filling of channels with sand and gravel and the presence of trash, yard waste, and dead animals in the drains and in the lake. Additionally, some poor management practices were noted during the study like a snow pile that had been shoveled from a parking lot and deposited on a slope three feet above a drain inlet on Washington Street (Figure 11).

FIGURE 7. Catch basin on storm drain network #3.

Drain Network #3: DESCRIPTION: This short drain network consists of one inlet off of Center Street East conducting water under residential property to the lake. See labeled photos #11-12. The catch basin has not been maintained. There is evidence that gravel and sand from the road and trash, yard refuse, etc. frequently enter the catch basin and are conducted to the lake. The mouth of the pipe at lake level has been filled up with debris and was not visible. Property owners in the area noted that the street surfaces have not been sloped and configured properly to ensure that water is routed toward storm sewer drains and catch basins. This causes water to flow across residential yards and streets to the lake channel. **WATERSHED:** The watershed is entirely residential and residential streets. **SAMPLING:** No sample was collected as water only passes into the catch basin when it is raining. **RECOMMENDATION:** The catch basin that accepts water needs to be properly maintained and cleaned. The catch basin located on Center Street could be retrofitted with a stormwater inlet filtration device for pollutant removal.

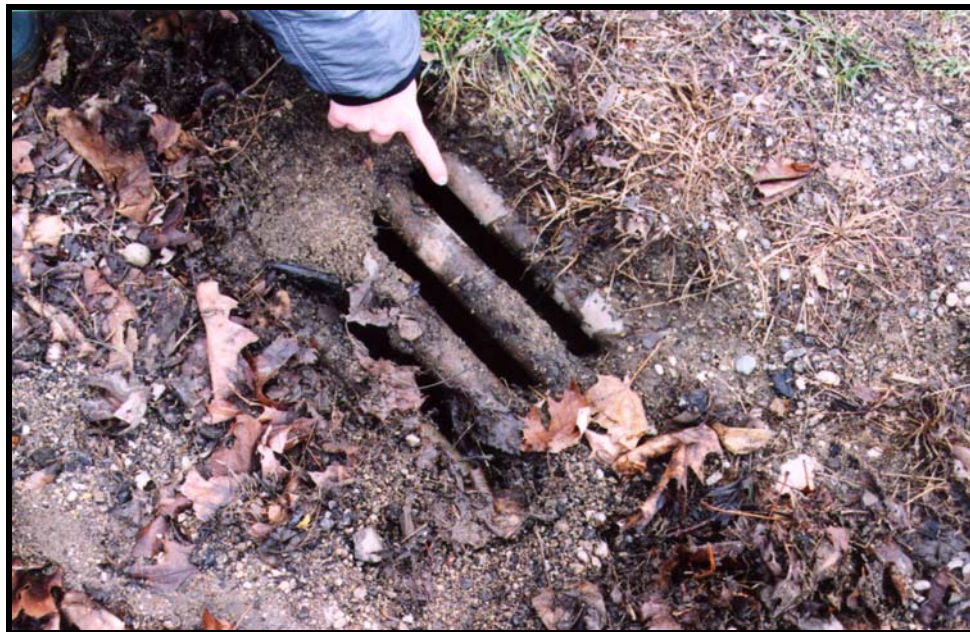
FIGURE 8. Catch basin on storm drain network #4.

Drain Network #4: DESCRIPTION: Network #4 is a 3-basin complex draining the southern bend of Albert Eckert Drive. See labeled photos 13-19. These catch basins have not been maintained either. The researcher believes that substantial sediment and sediment-related pollution introduction to the lake could be prevented if the catch basins were maintained. Of the 3-basin complex, basin b was completely clogged, and the drop structure at basin a was almost completely filled with sediment. There was also evidence of sand and gravel introduction to basin c from the road upslope. It was also noted during the study that water almost completely bypasses catch basin c and runs over the street to catch basin a and directly to the lake. The slope is not conducive to routing water catch basin c for filtration. **WATERSHED:** The watershed is entirely residential and residential streets. **SAMPLING:** No sample was collected as water only passes into the basins when it is raining. **RECOMMENDATION:** Catch basins a, b, and c of the 3-basin complex need to be properly maintained and cleaned. All three catch basins could be retrofitted with a stormwater inlet filtration device for pollutant removal. Of priority for filtration would be basins a, then b and c. Some pavement and curb reconfiguration and sloping is probably needed in this area to ensure effective drainage and storm water filtration although this recommendation is outside of the current study's scope.

| Drain | Priority | Drain Network Description | Recommended Project |
|---|---|---|--|
| #4 | High | 3-basin complex draining southern bend of Albert Eckert Drive | Maintain and retrofit catch basins a, b, and c; it was noted that water bypasses catch basin c almost completely and travels over the road to the lake |

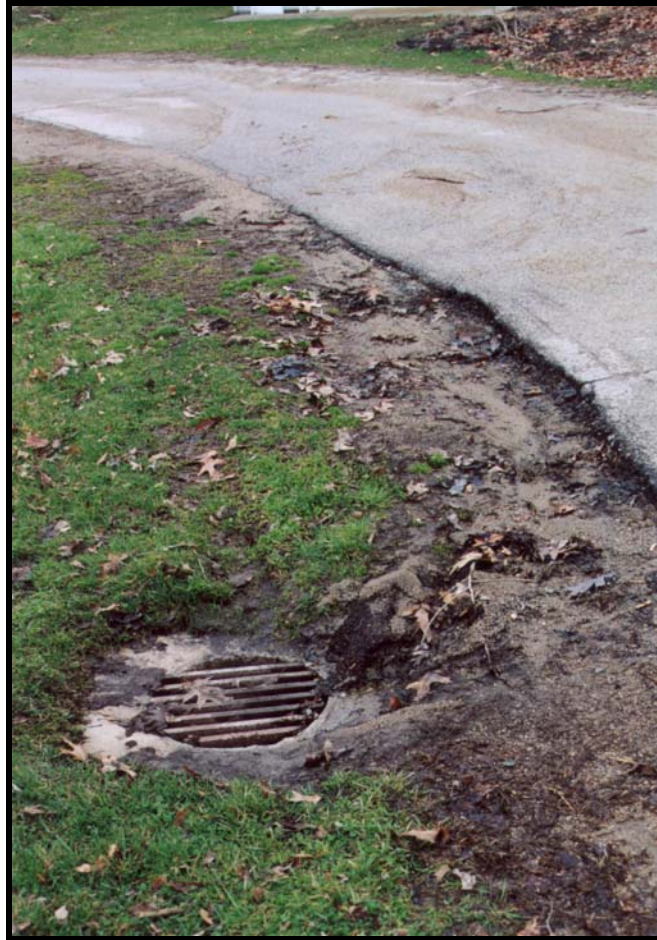
FIGURE 9. Catch basin on storm drain network #7.

Drain Network #7: DESCRIPTION: Drain network #7 accepts water from 3rd and 4th streets and conducts it via a 6" pipe to the lake. See labeled photos 30 and 31. The drop structure was almost completely filled in with sand and gravel. **WATERSHED:** The watershed is entirely residential and residential streets. **SAMPLING:** No sample was collected as water only passes into the network when it is raining. **RECOMMENDATION:** The catch basin that accepts water needs to be properly maintained and cleaned. The catch basin located at the intersection of 3rd and 4th Streets could be retrofitted with a stormwater inlet filtration device for pollutant removal.

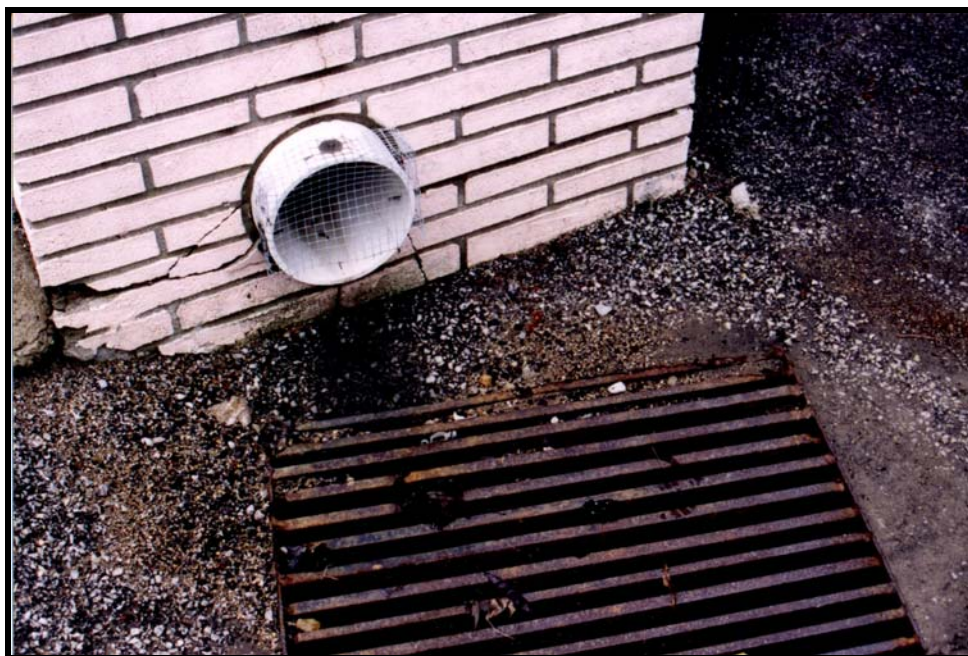
FIGURE 10. Catch basin on storm drain network #14.

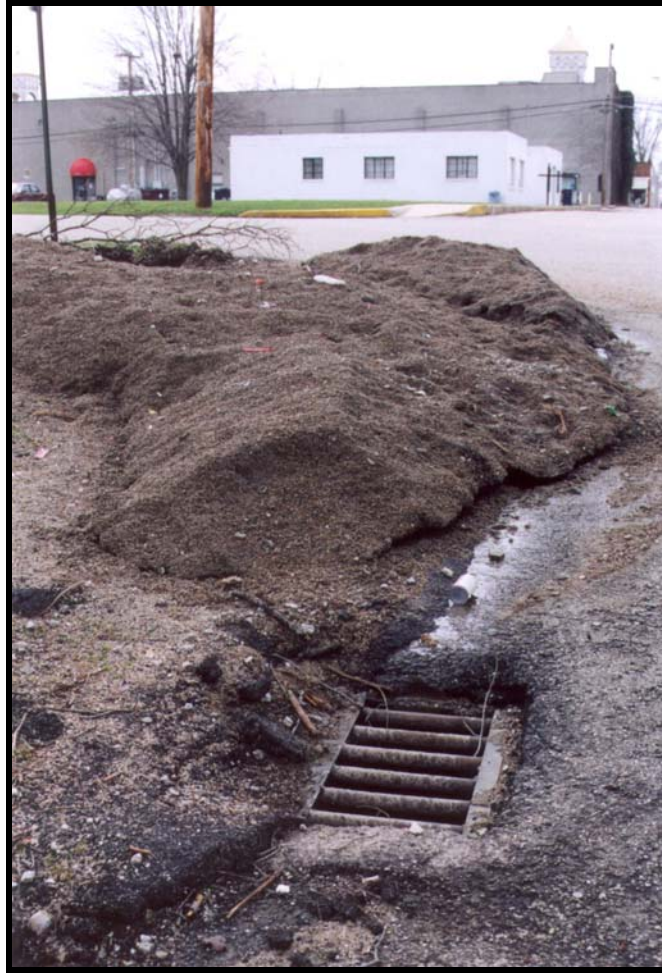
FIGURE 11. Catch basin on storm drain network #12.

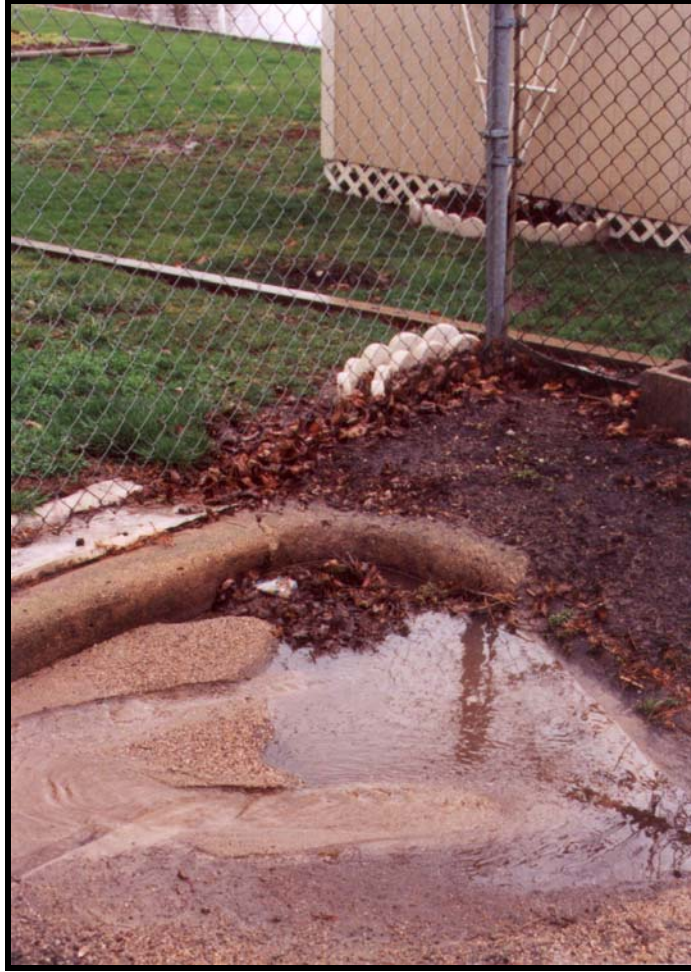
FIGURE 12. Catch basin on storm drain network #13.

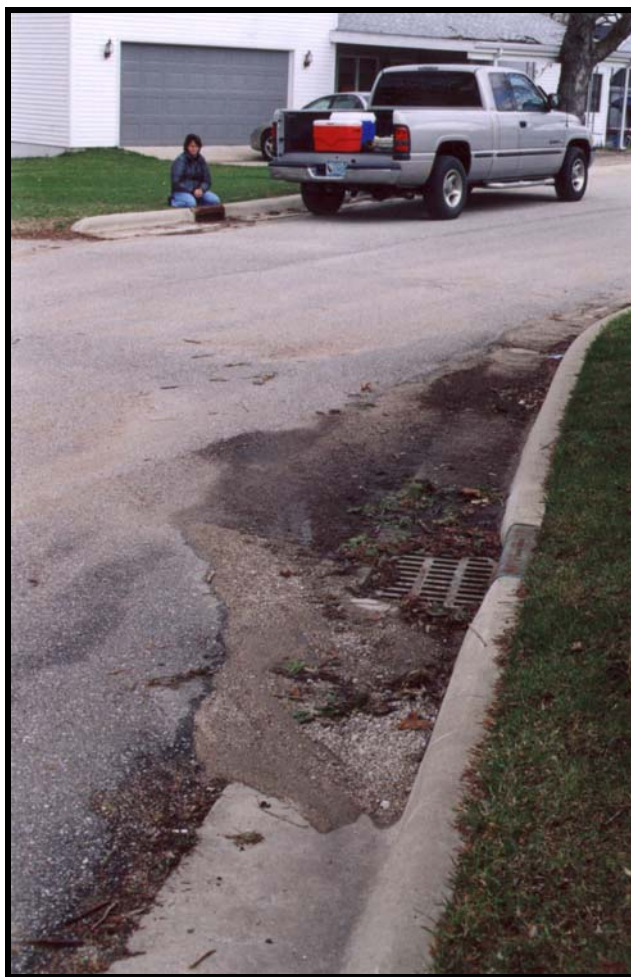
FIGURE 13. Catch basin on storm drain network #14.

Drain Network #14: DESCRIPTION: Drain network #14 is an eight-basin complex draining South Street and Mulberry Road to the lake. See photos 67-70. **WATERSHED:** The watershed is SR13, South Street, Mulberry Street, and residential. **SAMPLING:** No sample was collected as water only passes into the network when it is raining. **RECOMMENDATION:** All 8 catch basins could potentially be fitted with stormwater filtration devices. Based on observations made during the tour, the order of priority should be a, b, g, f, and then h.
